Patented fastener helps Air Liquide achieve leak-free start-up

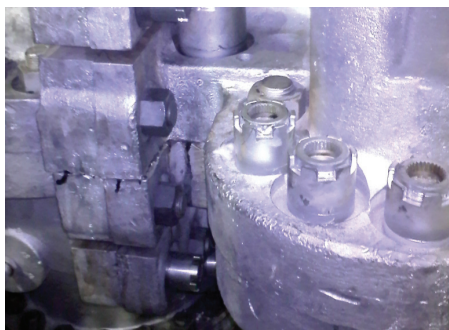
Horizontal and vertical flanges with clamp nuts.

Clearance issues on the horizontal flange made it nearly impossible for maintenance crews to apply even and accurate bolt load using standard hex nuts and jack screw nuts. The HYTORC technician determined the HYTORC Nut would be the perfect solution for the job, and the installation would be done with HYTORC AVANTI™ torque wrenches, which would fit in all areas. This would make the installation faster and safer, while accomplishing the overall goal of zero leakage on start-up. The service center's personnel were trained on the operation of the tools and the

HYTORC Nuts and supervised during installation to assure a smooth transition to this new technology. For the first time upon start-up, the horizontal flange was completely leak-free. Having solved this major headache, the crews noticed a leak on the nearby vertical flange. The unit ran uncovered for about two weeks

until inventory levels became less critical so it could be brought down and HYTORC Nuts could be installed on the vertical flange. Upon this start-up, both flanges were 100-percent leak-free. Almost one year later, the unit is still up and running with zero leaks.
