Optimizing a steam turbine in Mexico thermoelectric power plant

COISA, the HYTORC distributor in Mexico, was called to work on the Presidente Plutarco Elías Calles thermoelectric power plant in Petacalco, Guerrero, Mexico. The company was looking to optimize the maintenance procedures on one of the plant's Mitsubishi steam turbine units.

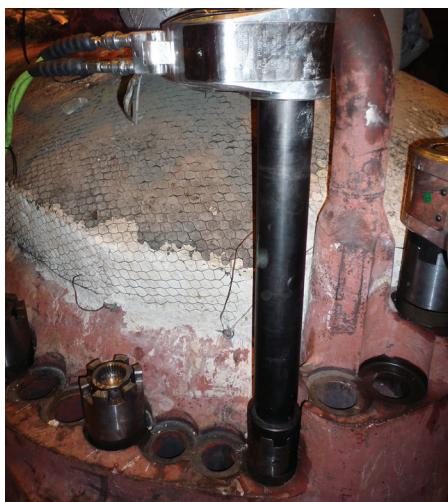
A HYTORC Nut is installed using the Avanti bolting system with an extended drive.
